# STRESSES IN THE TANK SHELL WITH SHAPE DEFORMATION

**KOWALSKI DARIUSZ**

Gdansk University of Technology, Gdańsk, Poland

**International Conference on Design, Inspection, Maintenance and Operation of Cylindrical Steel Tanks and Pipelines. Prague - Kralupy nad Vltavou, Czech Republic, 8-11 October 2003.**

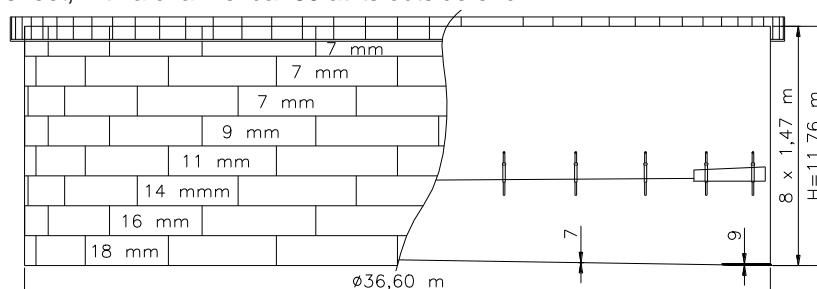
Fig. 1. Vertical section of the tested tank

The tested object was an above-ground cylindrical vertical tank with a floating roof of the pontoon-membrane type. The basic dimensions of the tank are shown in fig. 1, its general view is shown in fig. 2. The joint type used in the shell is both vertical and horizontal butt welds. On the last ring of the tank shell, a sealing wind ring is fitted. It is horizontal, 850 mm wide and made of 6 mm thick steel sheet, with a channel bar 80 at its outside end.

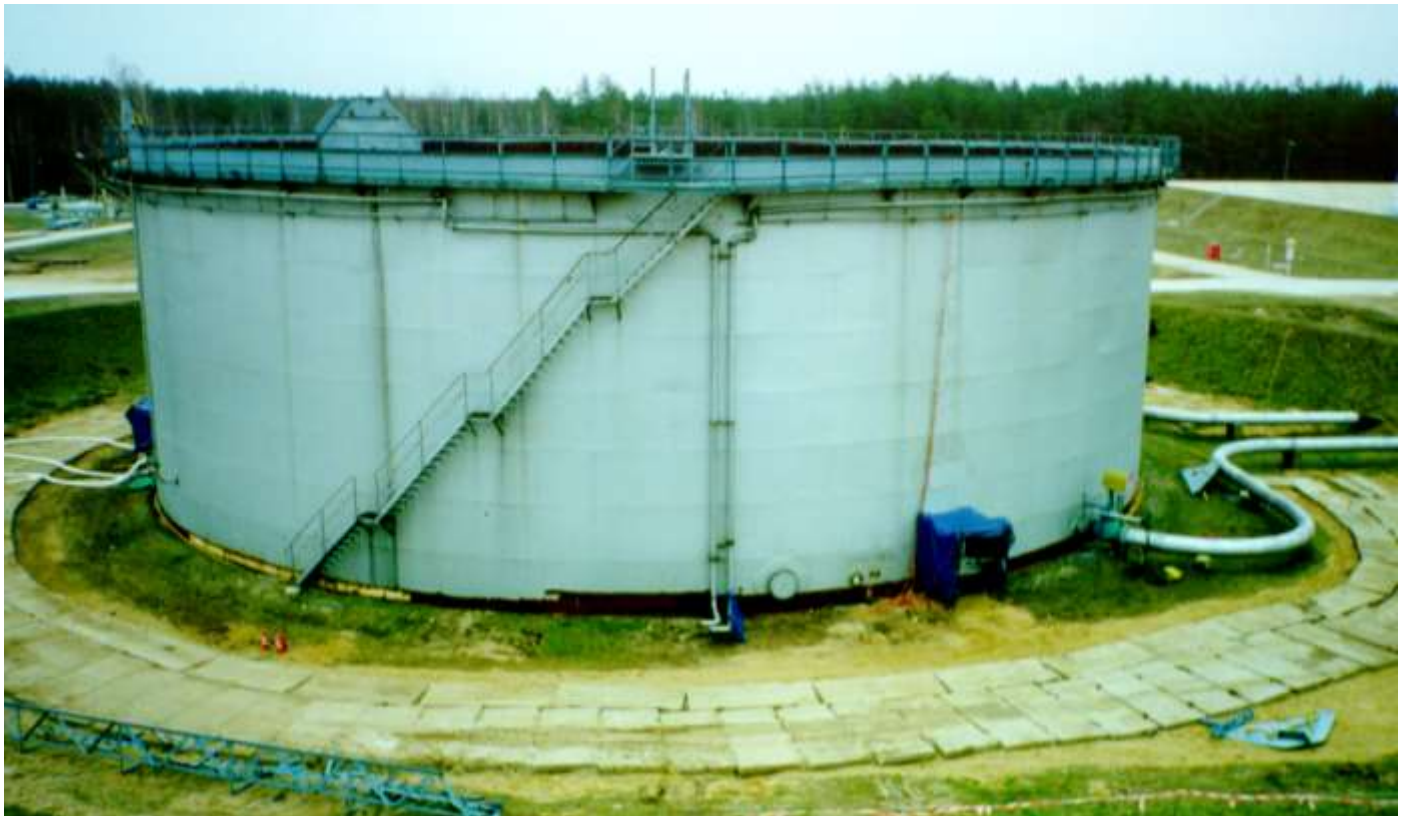
Fig. 2. General view of the tank

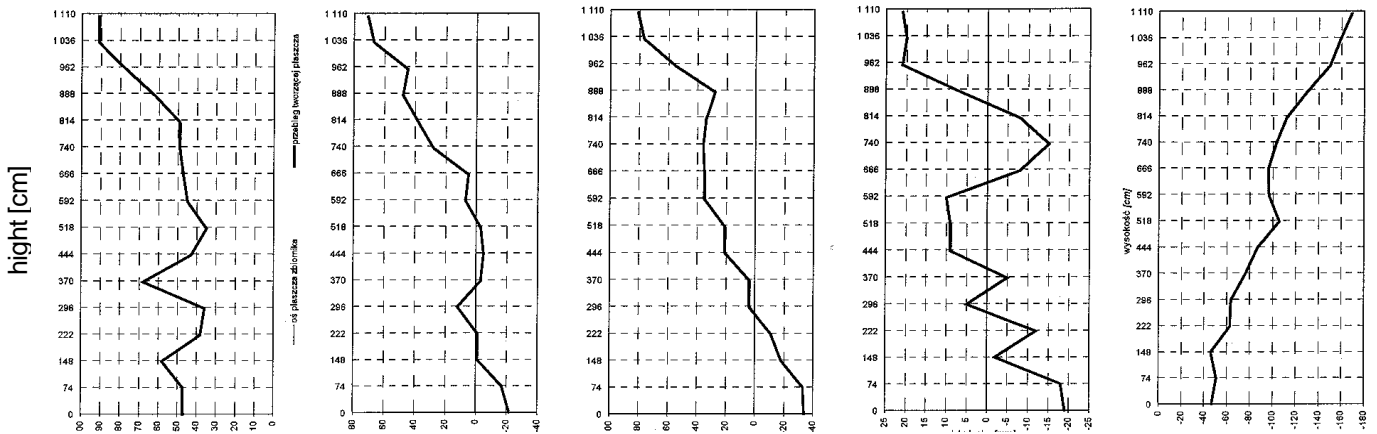
Fig. 3. Deformation at selected measurement plumb-lines of the tank shell

The settlement of the tank shell perimeter ranges from – 18 to 31 mm (difference of 49 mm at the circumference of the tank). The total value of tank settlement during the tank's service life is not known due to the lack of post-construction measurements. Total tank shell deformation resulting from construction imperfections and irregular settlement reaches the values of –169 mm (deformation inside the tank) to 149 mm (outside deformation).

In total, measurements were taken in 680 points of the empty tank. The nature of shell deformation can be seen on the enclosed selected measurement plumb-lines of the tank shell (fig. 3).

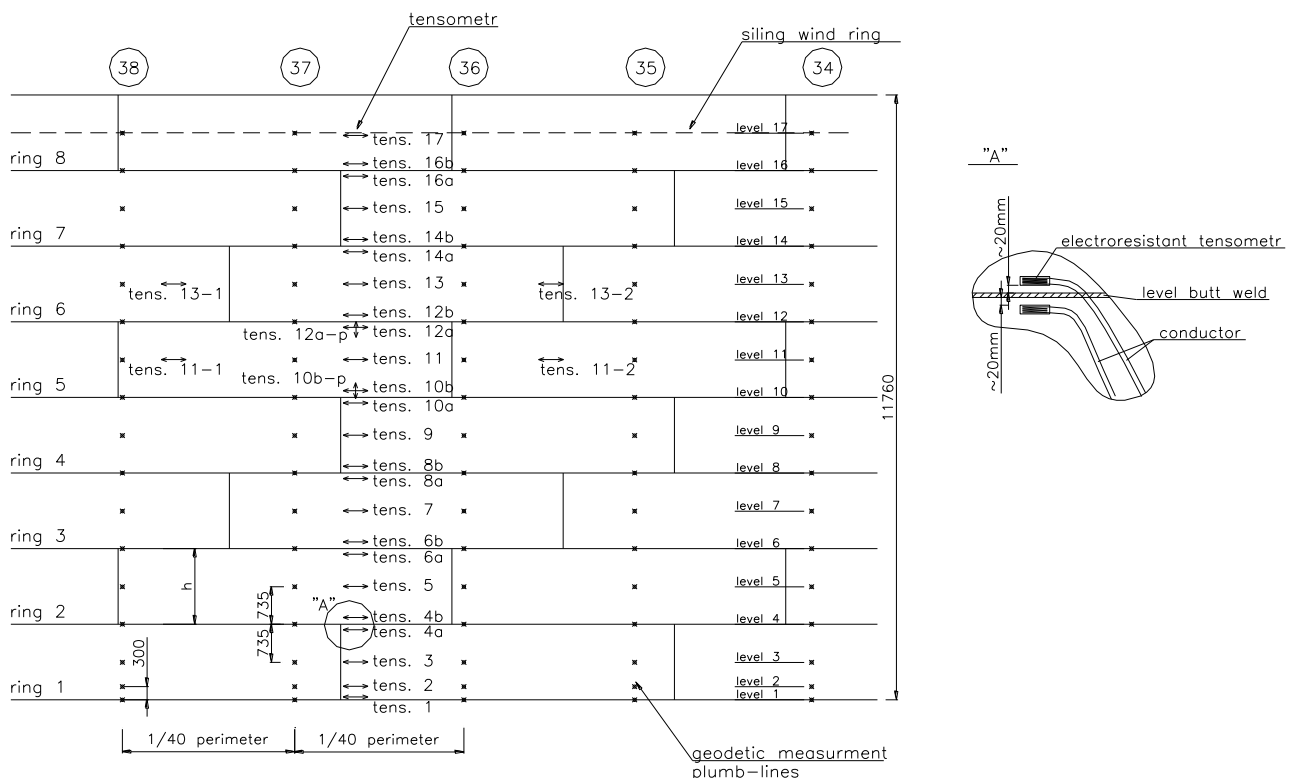
Fig. 4. Distribution of tensometers and measurement plumb-lines on the tank shell.

Furthermore, it was planned that three linear tensometers would be installed on each shell ring of the tank. They were fixed on the upper and lower edge of each ring 20 mm from horizontal welds and at least 150 mm from the vertical welds. Tensometers were also installed in the middle of each shell ring. In the course of installation it was decided that the number of measurement points would be increased and thus, additional horizontal tensometers were installed on rings 5 and 6 on the vertical measurement plumb-line no 1. They were fixed on both sides of the plumb-line at 3 meters length. Single additional vertical tensometers were also fixed on each measurement plumb-line in the places of the highest angular refraction between sheets at the horizontal welds (fig. 4).

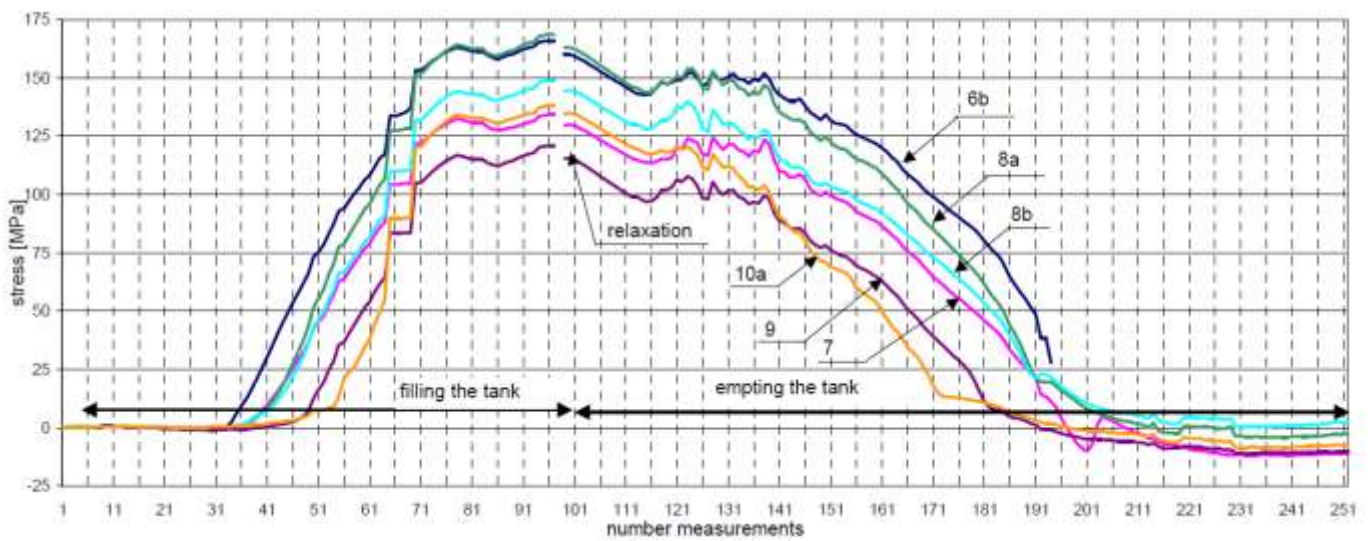
Fig. 5. Recorded variability of stress ( measurement levels according to fig. 4)

The measurements of deformation of the steel tank shell were taken with the utilisation of electroresistant tensometric converters LY 11 6/120 which were made by Hottinger Baldwin Messtechnik company, and glued to the construction with glues made by Measurements Group. The course of the performed tests was recorded with the use of PC computers co-operating with multipoint measurement systems UPM 60 and ONIX 64. Tests were carried out using the measuring apparatus of the Bridge Department of Technical University of Gdańsk and with the participation of this department’s staff. The measurements were to be taken in two complete measurement cycles (i.e. two cycles of filling and emptying the tank), however the weather conditions – a sudden return of winter and a 20°C temperature fall as well as technical difficulties limited the works to one complete cycle and the initiation of filling in the second cycle. The values of stress in the tank shell were recorded automatically every 15 minutes. The variability of stress values recorded during the measurements is shown in fig. 5.

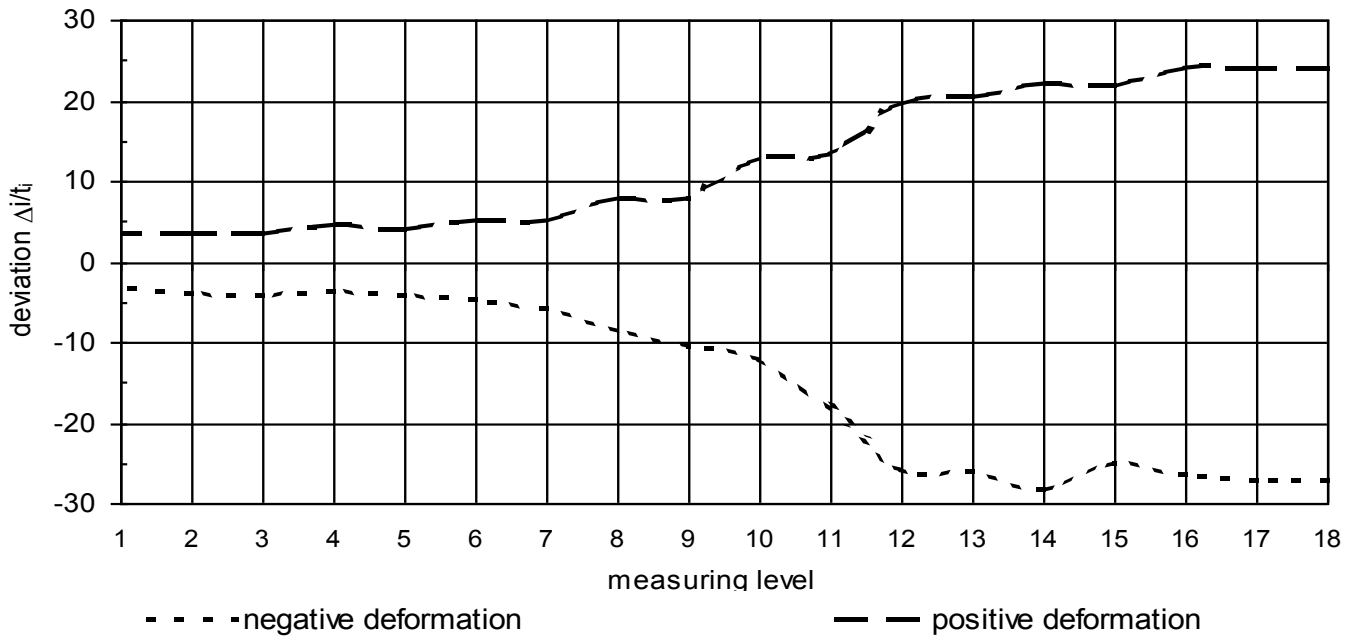
Fig. 6. Deformation standardised with the real shell plate thickness

The tested tank is one of the most deformed objects in this group of steel constructions. Thanks to standardising the value of deformation  $\epsilon_i$  with the real value of thickness  $t_i$  of tank shell plates on a given level, we obtain the values of variability ranging from 3,3 to 28,3. Fig. 6 presents a detailed study of the deviations. Such imperfections result in visible eccentrics between particular elements of the tank shell rings, which leads to generating not only circumferential stretching forces in the cylindrical shell of the tank but also considerable values of vertical forces and bending moments. Fig. 7 shows an example of perturbation of circumferential stretching forces for the analysed measurement plumb-lines, with the results for the shells with imperfections and for ideal shells.

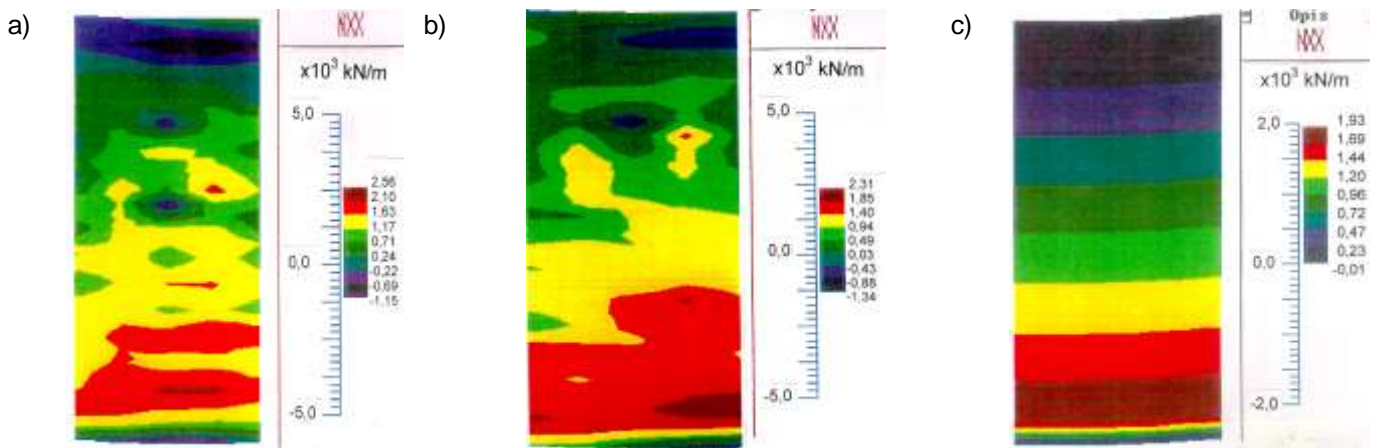
Fig. 7. Comparison of circumferential stretching forces in the shell a), b) with imperfections, c) ideal

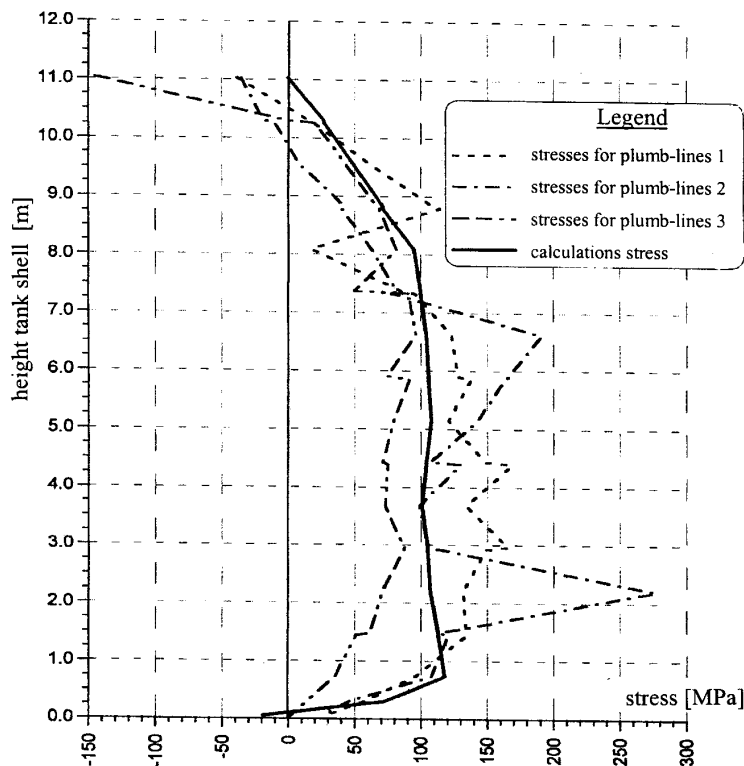
Fig. 8. Comparison of measured and calculated stress values

The stress values obtained in the tests were compared with the values calculated for an ideal (ideally shaped) tank. This comparison is presented on a graph (fig. 8). On the basis of the comparison of measured and calculated stress values, it was found that the shape deformation of the shell considerably alters the local stress values calculated for the ideal shell shape. The results obtained on the second measuring plumb-line on the fifth level can be a clear example of this. There, the stress values were more than twice as high as the expected values (258 %). The values obtained in computer calculations with the utilisation of finished elements method for deformed shells are not satisfactory and therefore they have not been presented in this paper.

The reason for such a poor match of the computer calculations may be either a poor convergence of the calculation process or a poor match of the characteristic of the elements used for modelling the shell. Therefore, further attempts have been made with the utilisation of another system of modelling and software in order to find a satisfactory relationship between the values of imperfection and the resulting change of stress values.
