STRESSES IN THE TANK SHELL WITH SHAPE DEFORMATION

KOWALSKI DARIUSZ

International Conference on Design, Inspection, Maintenance and Operation of Cylindrical Steel Tanks and Pipelines. Prague - Kralupy nad Vltavou, Czech Republic, 8-11 October 2003.

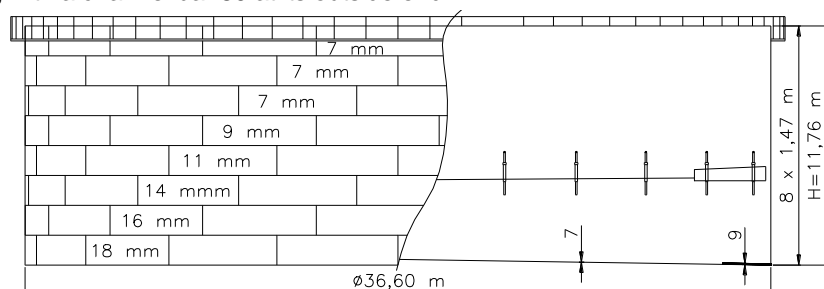
Fig. 1. Vertical section of the tested tank

The tested object was an above-ground cylindrical vertical tank with a floating roof of the pontoon-membrane type. The basic dimensions of the tank are shown in fig. 1, its general view is shown in fig. 2. The joint type used in the shell is both vertical and horizontal butt welds. On the last ring of the tank shell, a sealing wind ring is fitted. It is horizontal, 850 mm wide and made of 6 mm thick steel sheet, with a channel bar 80 at its outside end.

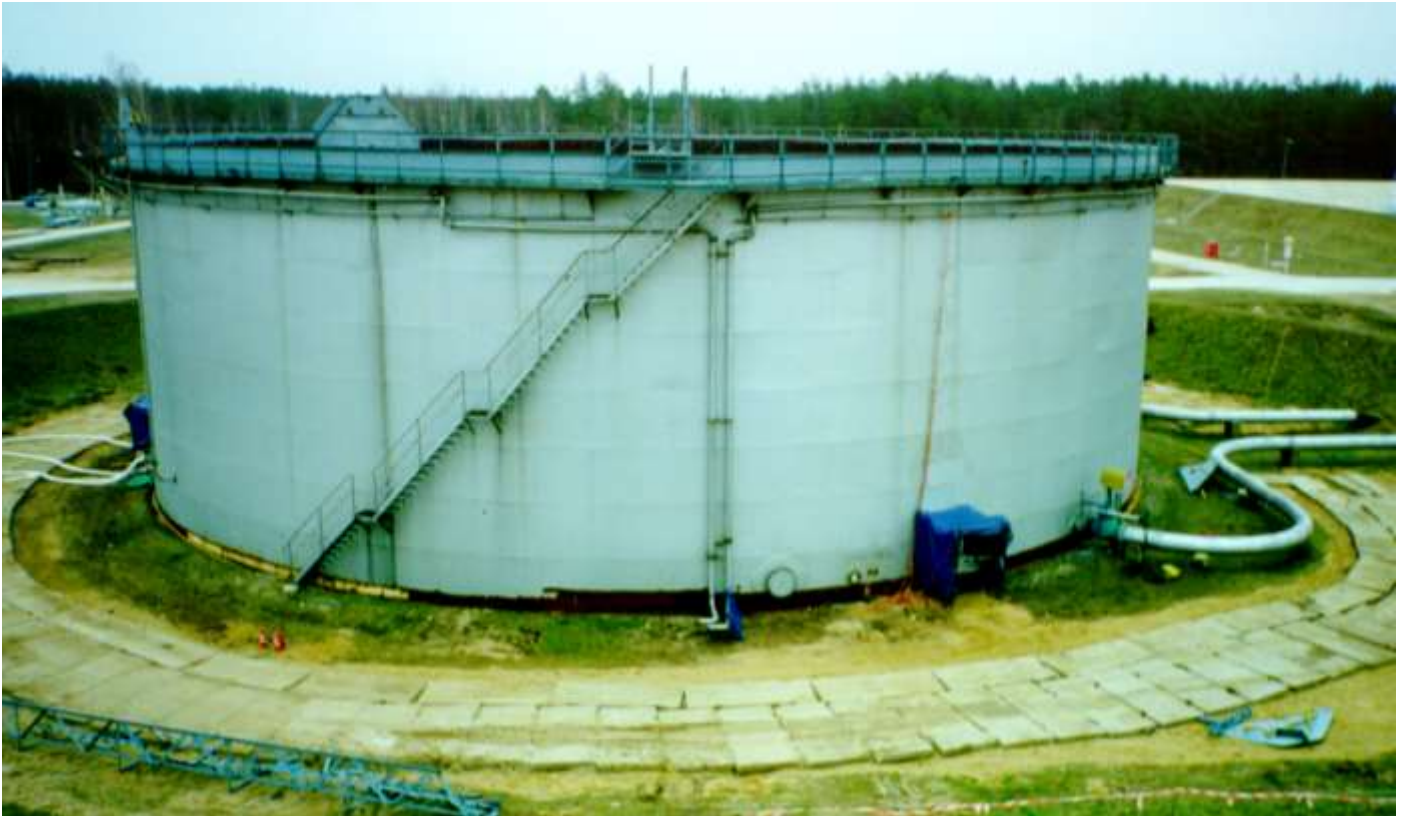
Fig. 2. General view of the tank

The tank is placed on sand foundations encircled by a foundation ring made of reinforced concrete. The tested tank was constructed in the years 1961 – 63 and since 1963 it has been operated incessantly.

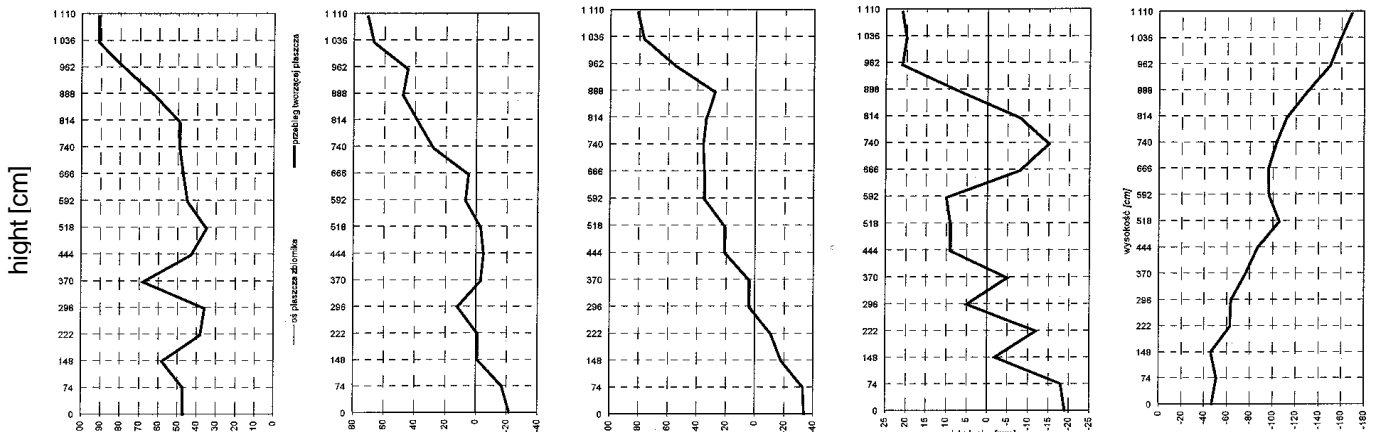
Fig. 3. Deformation at selected measurement plumb-lines of the tank shell

The existing shell deformation state was recreated on the basis of geodetic measurements, which were taken on 40 plumb-lines located uniformly on the tank's perimeter. The measurements were made on each tank shell ring on three levels (on the lower rim, on the middle rim and on the upper rim), with an additional measurement on the level of 300 mm above the tank's bottom.

In total, measurements were taken in 680 points of the empty tank. The nature of shell deformation can be seen on the enclosed selected measurement plumb-lines of the tank shell (fig. 3).

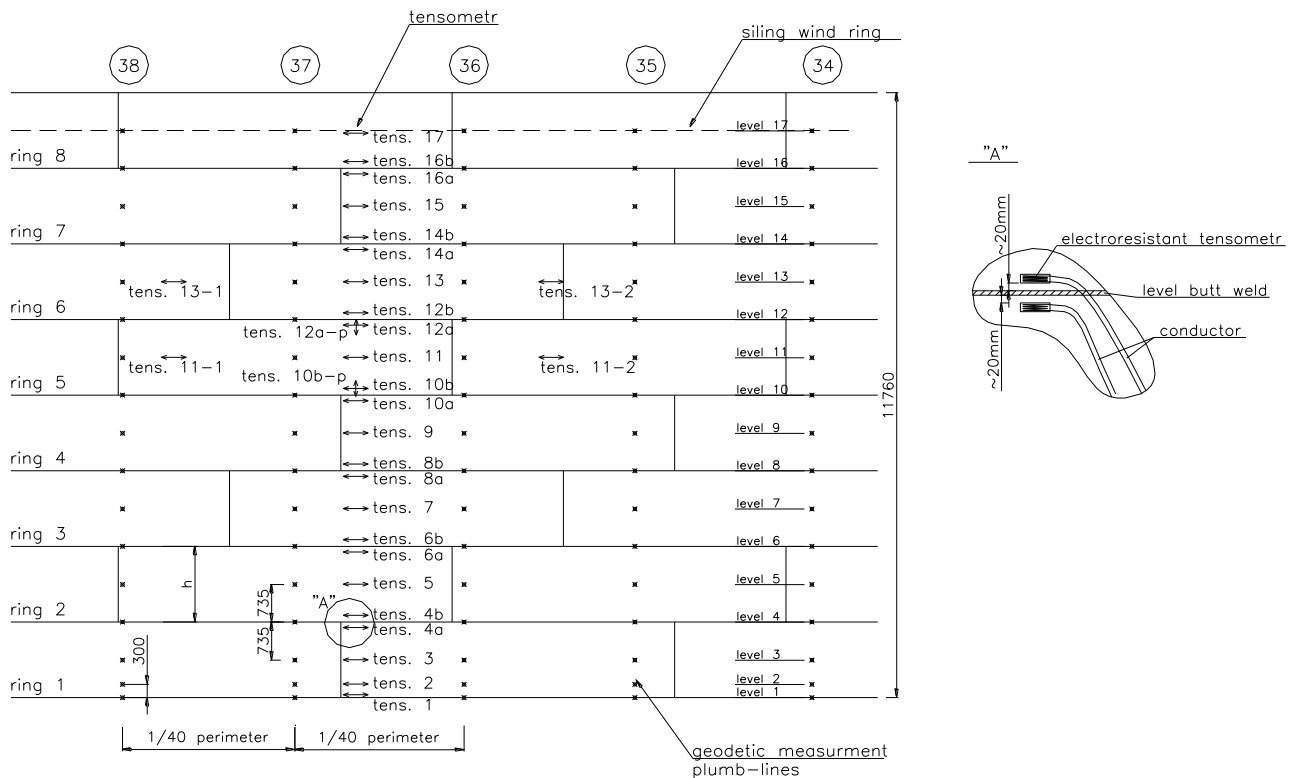
Fig. 4. Distribution of tensometers and measurement plumb-lines on the tank shell.

Furthermore, it was planned that three linear tensometers would be installed on each shell ring of the tank. They were fixed on the upper and lower edge of each ring 20 mm from horizontal welds and at least 150 mm from the vertical welds. Tensometers were also installed in the middle of each shell ring. In the course of installation it was decided that the number of measurement points would be increased and thus, additional horizontal tensometers were installed on rings 5 and 6 on the vertical measurement plumb-line no 1. They were fixed on both sides of the plumb-line at 3 meters length. Single additional vertical tensometers were also fixed on each measurement plumb-line in the places of the highest angular refraction between sheets at the horizontal welds (fig. 4).

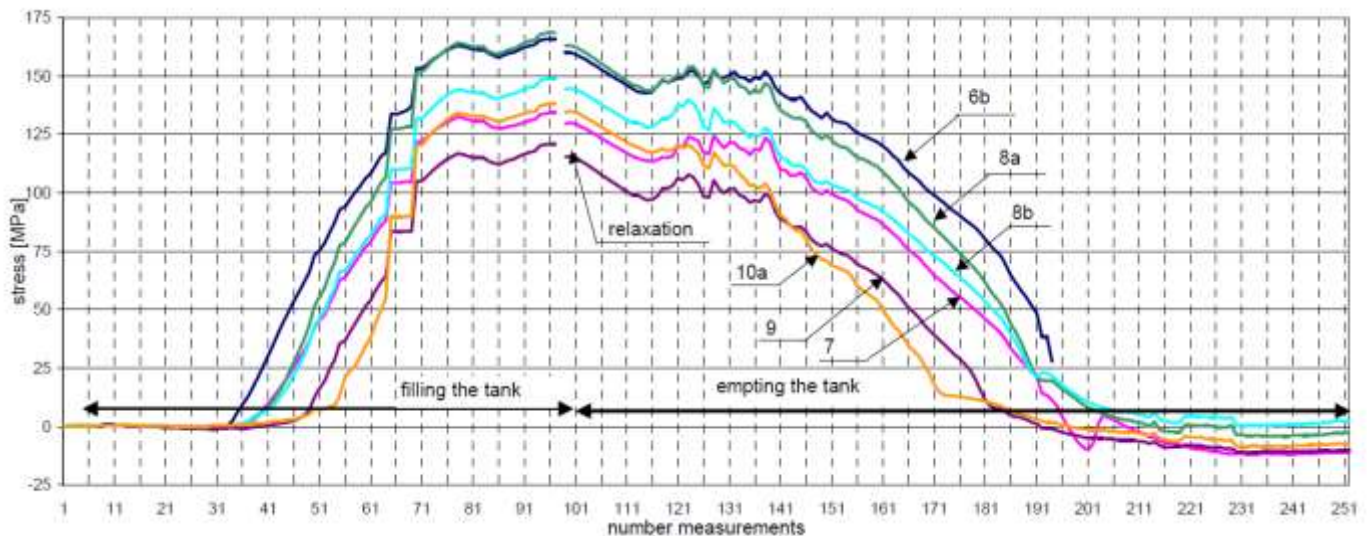
Fig. 5. Recorded variability of stress (measurement levels according to fig. 4)

The measurements of deformation of the steel tank shell were taken with the utilisation of electroresistant tensometric converters LY 11 6/120 which were made by Hottinger Baldwin Messtechnik company, and glued to the construction with glues made by Measurements Group. The course of the performed tests was recorded with the use of PC computers co-operating with multipoint measurement systems UPM 60 and ONIX 64. Tests were carried out using the measuring apparatus of the Bridge Department of Technical University of Gdańsk and with the participation of this department's staff. The measurements were to be taken in two complete measurement cycles (i.e. two cycles of filling and emptying the tank), however the weather conditions – a sudden return of winter and a 20°C temperature fall as well as technical difficulties limited the works to one complete cycle and the initiation of filling in the second cycle. The values of stress in the tank shell were recorded automatically every 15 minutes. The variability of stress values recorded during the measurements is shown in fig. 5.

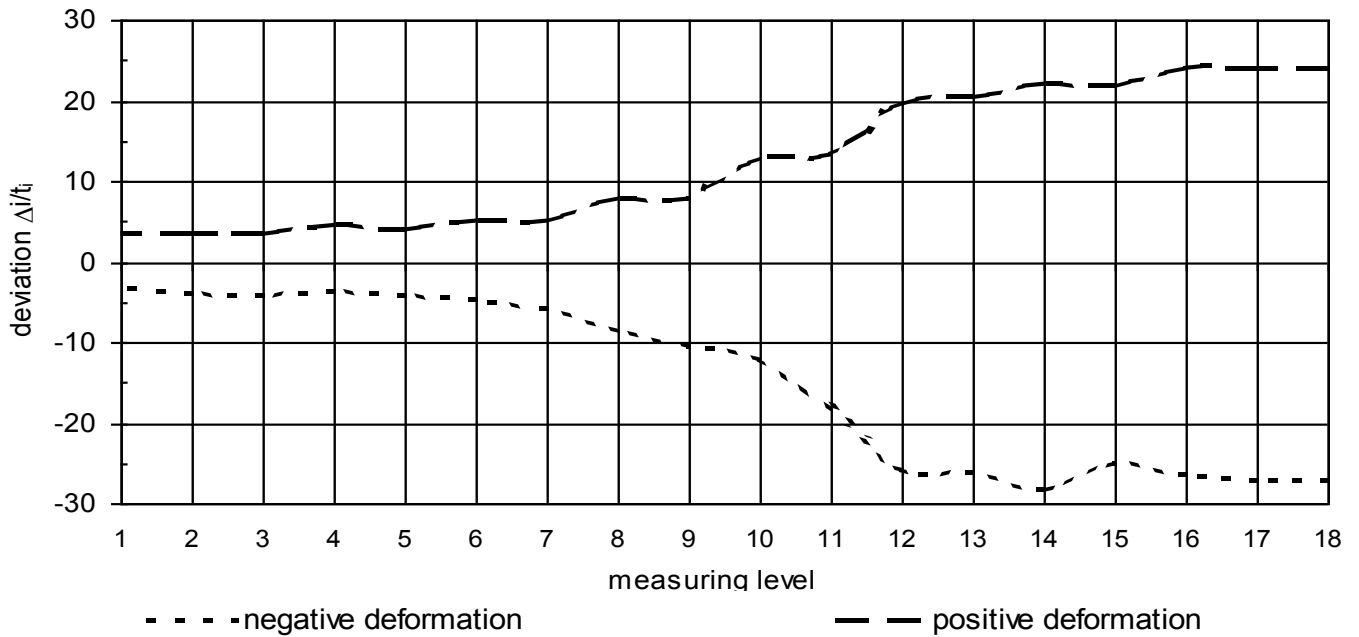
Fig. 6. Deformation standardised with the real shell plate thickness

The tested tank is one of the most deformed objects in this group of steel constructions. Thanks to standardising the value of deformation ϵ_i with the real value of thickness t_i of tank shell plates on a given level, we obtain the values of variability ranging from 3,3 to 28,3. Fig. 6 presents a detailed study of the deviations. Such imperfections result in visible eccentricities between particular elements of the tank shell rings, which leads to generating not only circumferential stretching forces in the cylindrical shell of the tank but also considerable values of vertical forces and bending moments. Fig. 7 shows an example of perturbation of circumferential stretching forces for the analysed measurement plumb-lines, with the results for the shells with imperfections and for ideal shells.

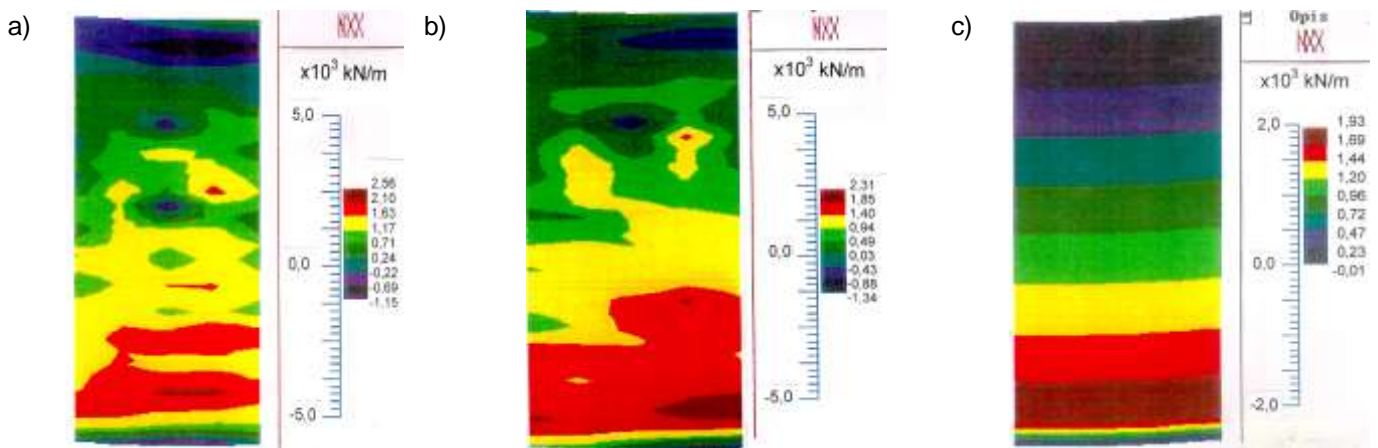
Fig. 7. Comparison of circumferential stretching forces in the shell a), b) with imperfections, c) ideal

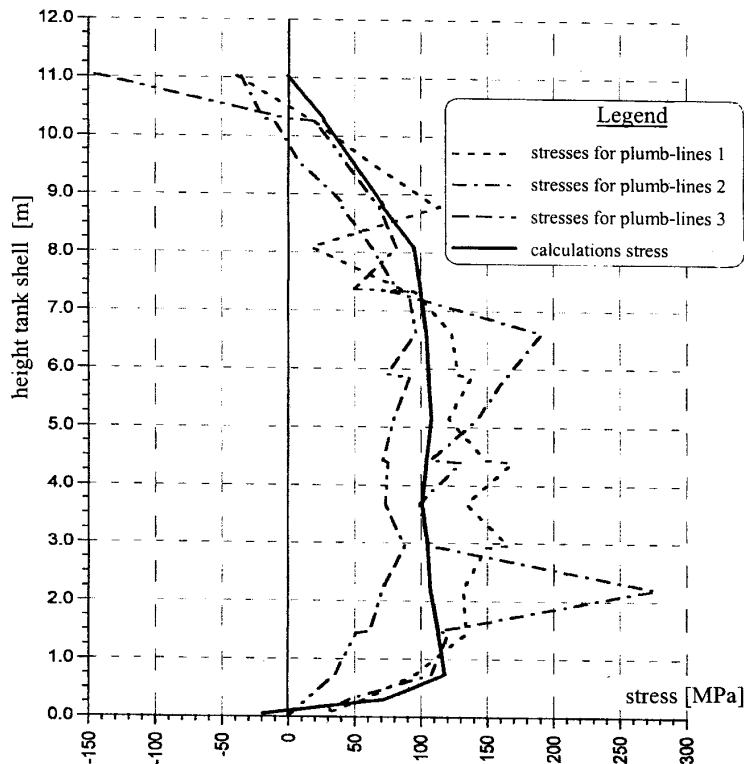
Fig. 8. Comparison of measured and calculated stress values

The stress values obtained in the tests were compared with the values calculated for an ideal (ideally shaped) tank. This comparison is presented on a graph (fig. 8). On the basis of the comparison of measured and calculated stress values, it was found that the shape deformation of the shell considerably alters the local stress values calculated for the ideal shell shape. The results obtained on the second measuring plumb-line on the fifth level can be a clear example of this. There, the stress values were more than twice as high as the expected values (258 %). The values obtained in computer calculations with the utilisation of finished elements method for deformed shells are not satisfactory and therefore they have not been presented in this paper.

The reason for such a poor match of the computer calculations may be either a poor convergence of the calculation process or a poor match of the characteristic of the elements used for modelling the shell. Therefore, further attempts have been made with the utilisation of another system of modelling and software in order to find a satisfactory relationship between the values of imperfection and the resulting change of stress values.
